Appendix 7-A. Organic maceral photomicrographs

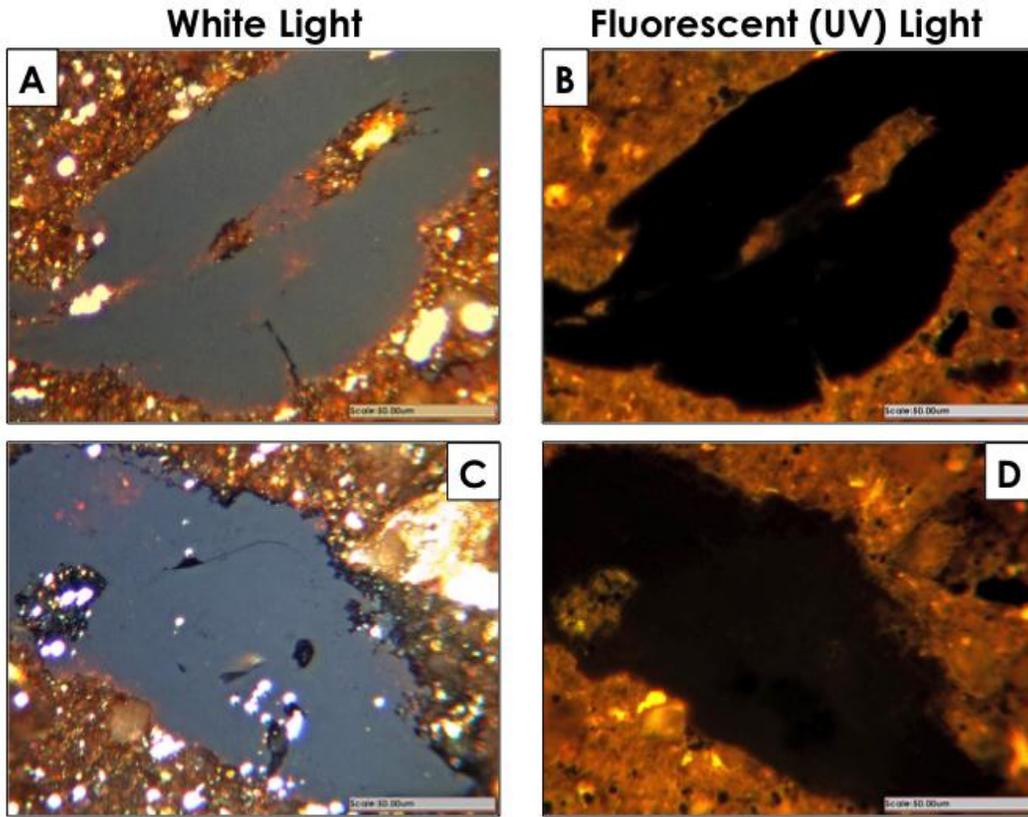
Plate 1 – A and C) White light images of bitumen from Kentucky samples ($R_o = 0.75\%$), B and D) Fluorescent light images of the same material. The dull yellow fluorescing material is amorphinite; the brighter yellow fluorescing “specks” are liptodetrinite.

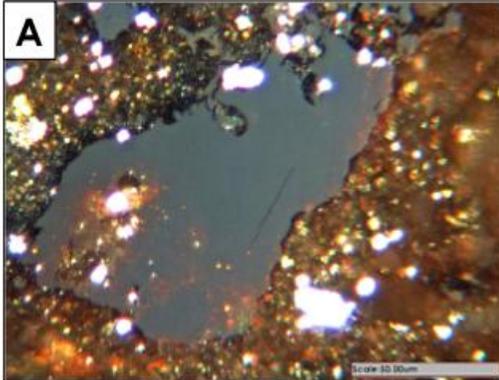
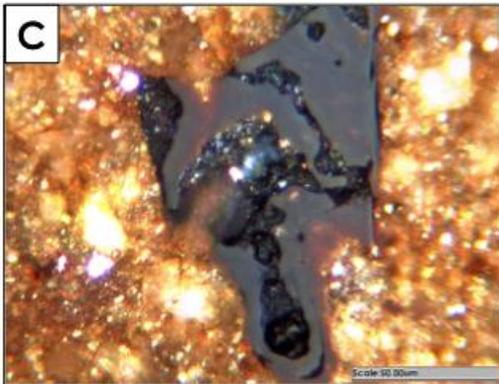
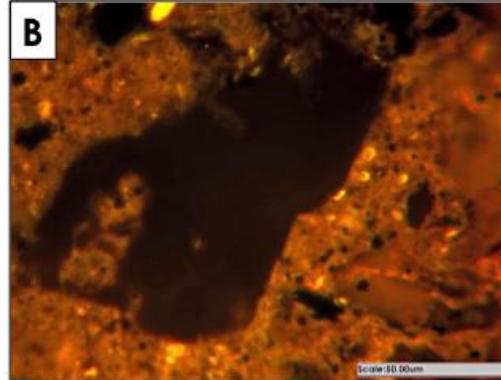
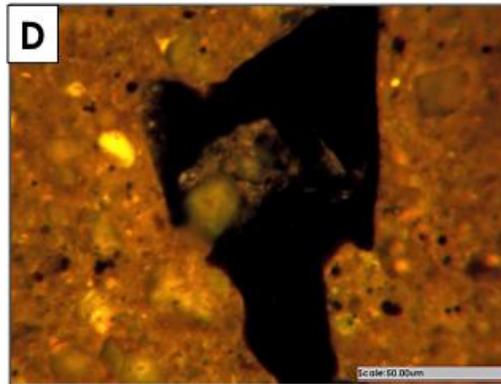
Plate 2 - A and C) White light images of bitumen from Kentucky samples ($R_o = 0.75\%$). The very bright reflecting material in all images is the mineral pyrite, B and D) Fluorescent light images of the same material. The dull yellow fluorescing material is amorphinite; the brighter yellow fluorescing "specks" are liptodetrinite.

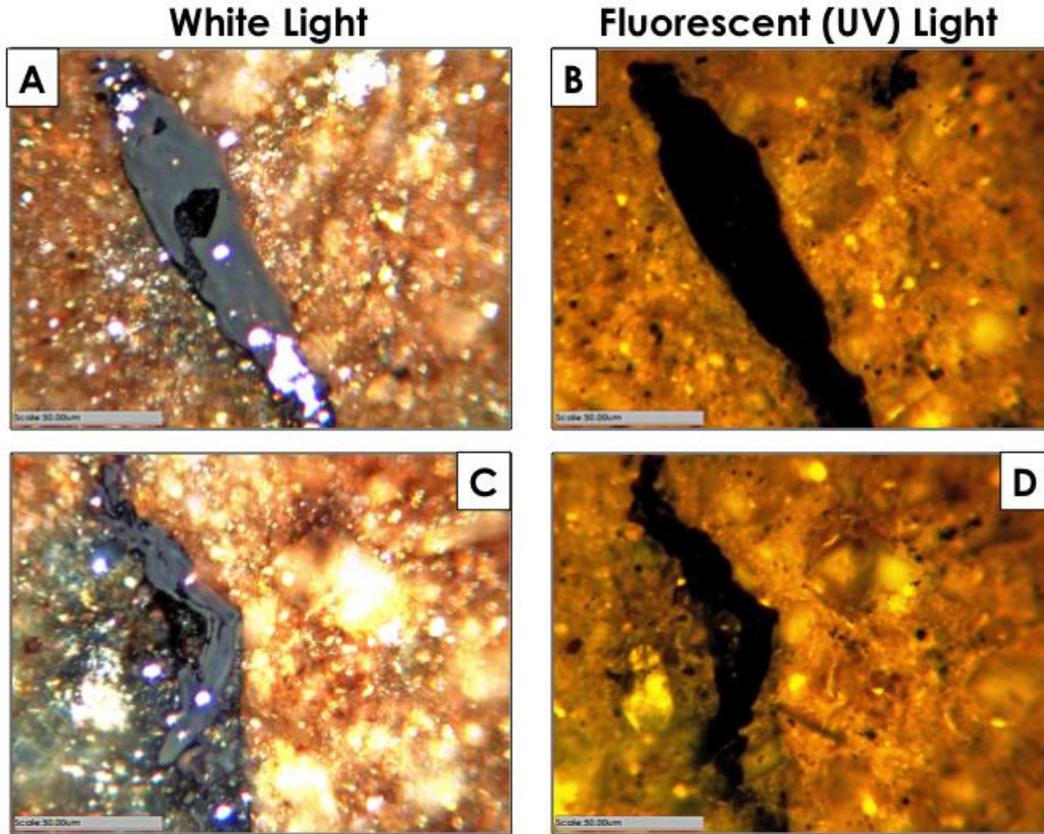
Plate 3 - A and C) White light images of bitumen from central Ohio samples ($R_o = 0.76\%$), B and D) Fluorescent light images of the same material, showing an abundance of amorphinite coating the shale matrix, adjacent to the pieces of bitumen.

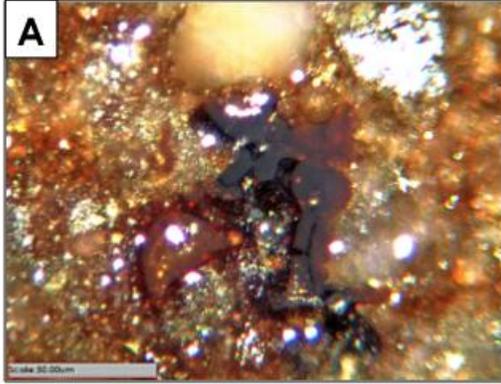
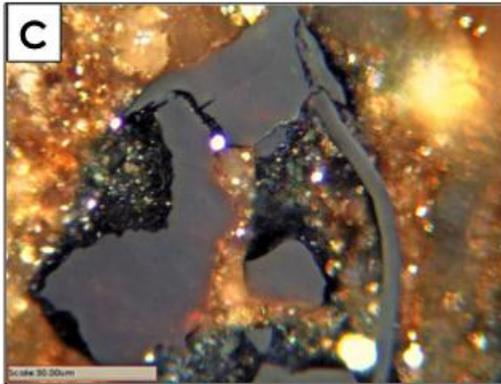
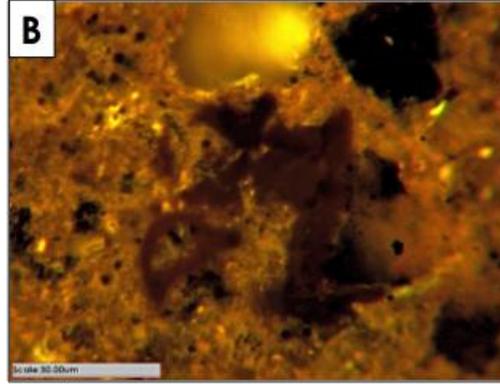
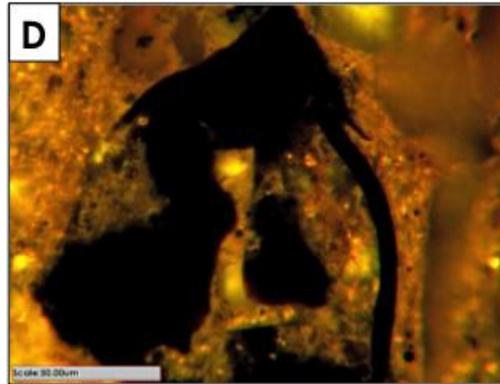
Plate 4 - A and C) White light images of bitumen from central Ohio samples ($R_o = 0.70\%$), B and D) Fluorescent light images of the same material; image B has a low fluorescence, while the bitumen in image D is non-fluorescing.

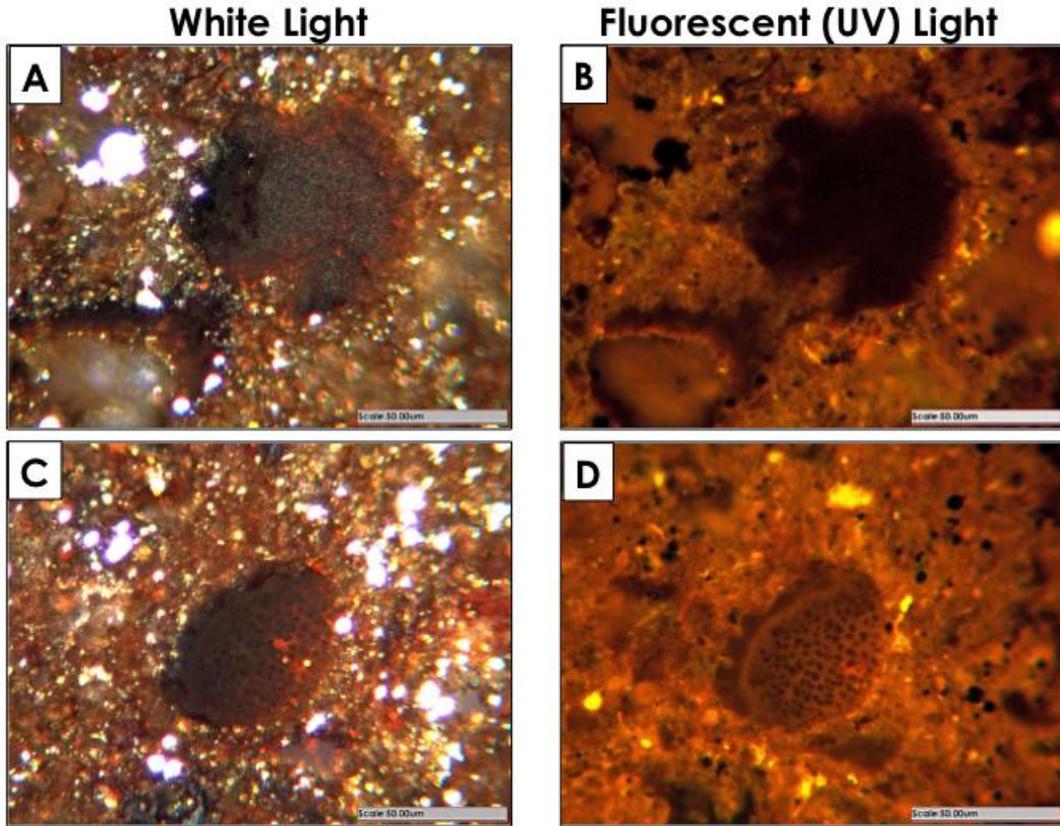
Plate 5 - A and C) White light images of *Gloeocapsomorpha prisca* from northeastern Ohio, B and D) Fluorescent light images of the same material. Note the darker (yellow-orange) appearance of the amorphinite surrounding the *G. prisca* grains, indicating a higher level of thermomaturity ($R_o = 1.1\%$).

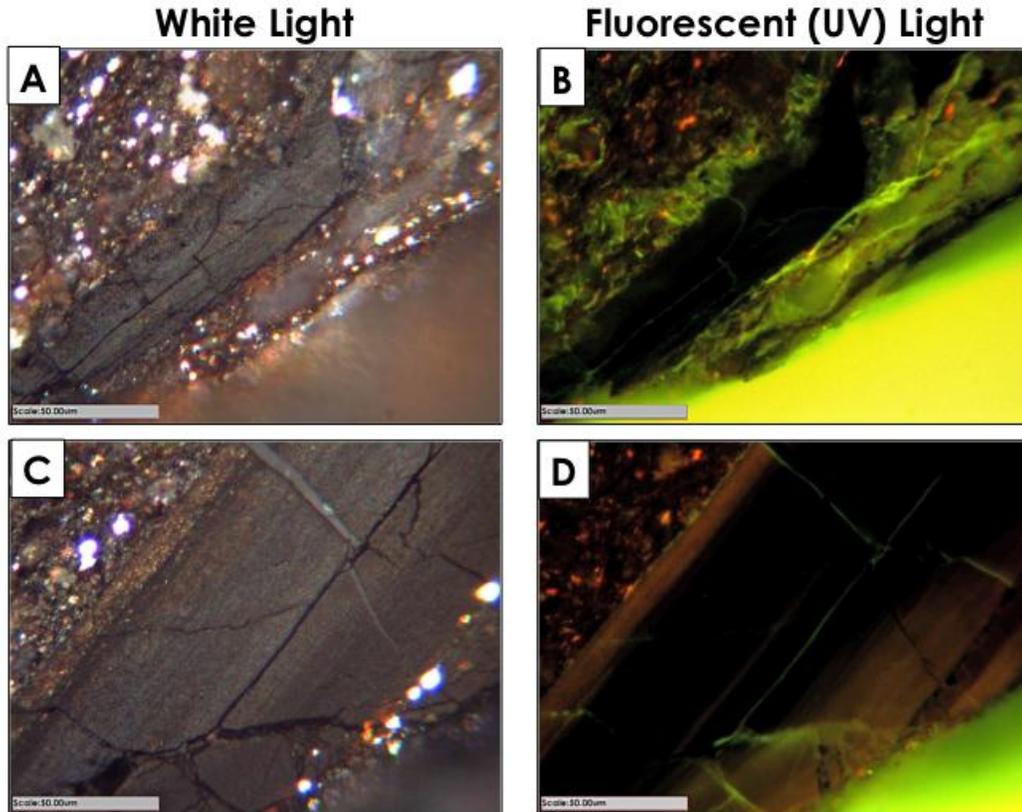
Plate 6 – A and C) White light images of grahamite, with characteristic coarse surface texture from northeastern Ohio ($R_o = 1.17\%$), B and D) Fluorescent light images of the same material. The grahamite is weak to non-fluorescing; amorphinite and liptodetrinite surrounding the bitumen grains are orange-red, which is characteristic for this level of thermomaturation. The bright green fluorescing material is epoxy.

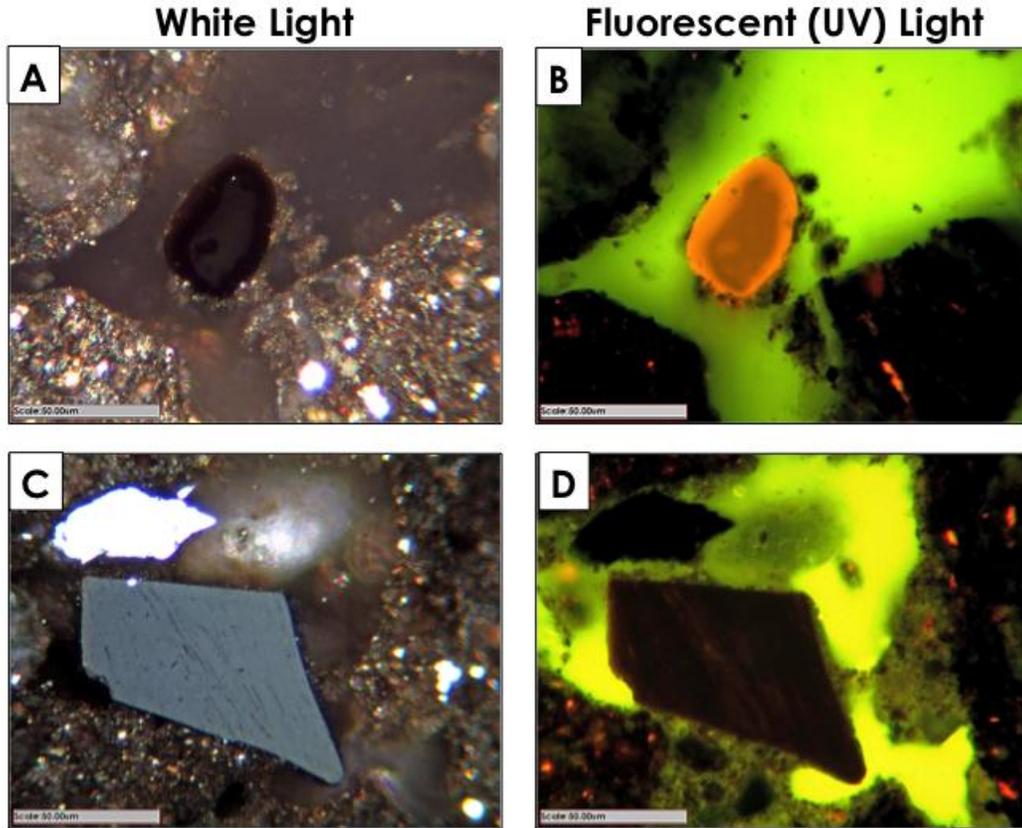
Plate 7 - A and B) White/blue light image pair of a relatively high fluorescing piece of bitumen from northeastern Ohio ($R_o = 1.16$). C and D) White/blue light image pair of a low fluorescing piece of bitumen from northeastern Ohio ($R_o = 0.96$).

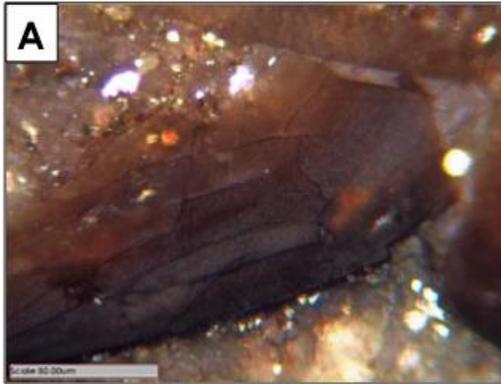
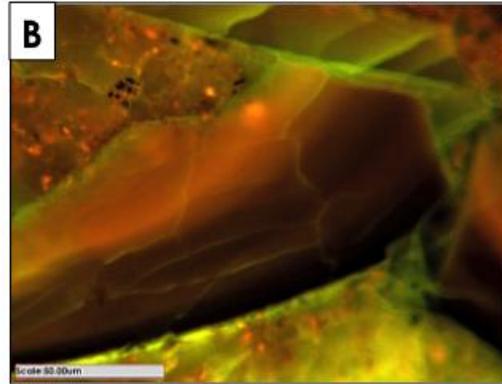
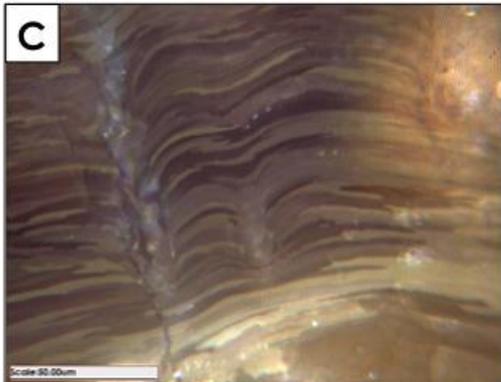
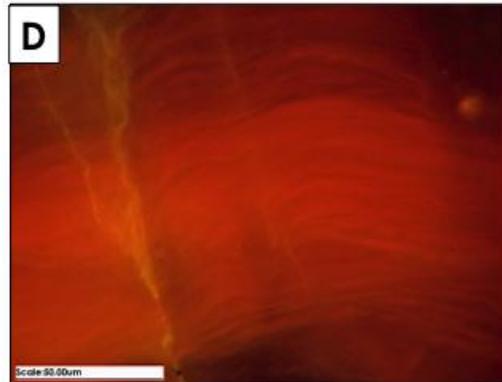
Plate 8 – A and B) White/blue light image pair of grahamite from northeastern Ohio (Ro = 0.96 %), part of which exhibits some fluorescence, C and D) possible zooclast with dull red fluorescence from northeastern Ohio (Ro = 1.34 %). The cause of the fluorescence is unclear, but may be the result of impregnation by petroleum liquids. The red fluorescence color reflects the advanced degree of thermomaturation.

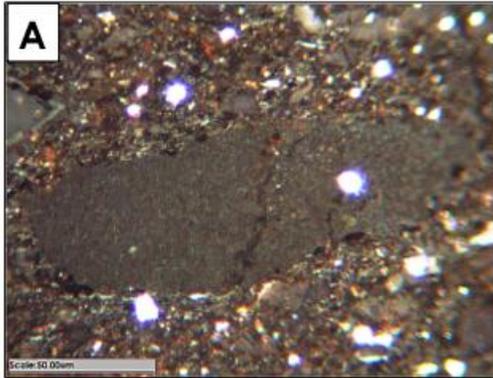
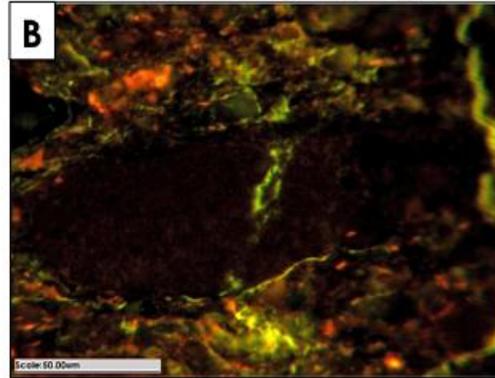
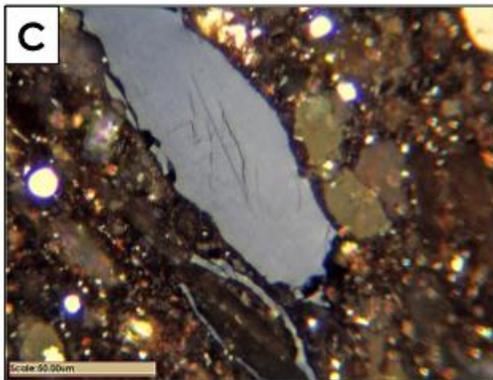
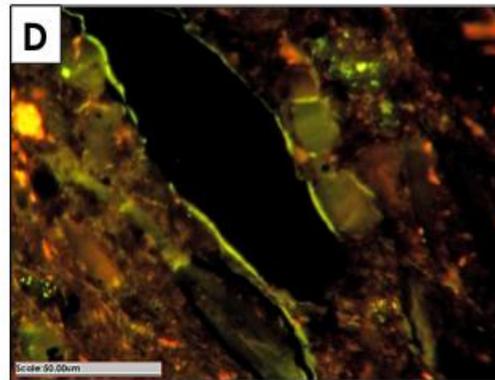
Plate 9 – A and B) White/blue light image pair of grahamite from northeastern Ohio (Ro = 1.12 %), showing characteristic coarse surface texture, C and D) epi-impsonite from the same sample, showing a very smooth surface texture.

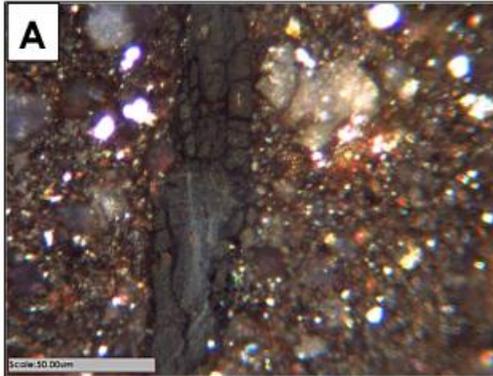
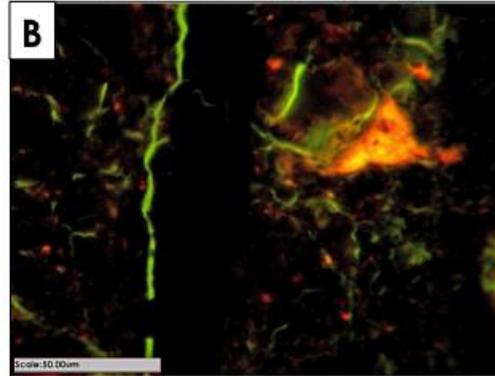
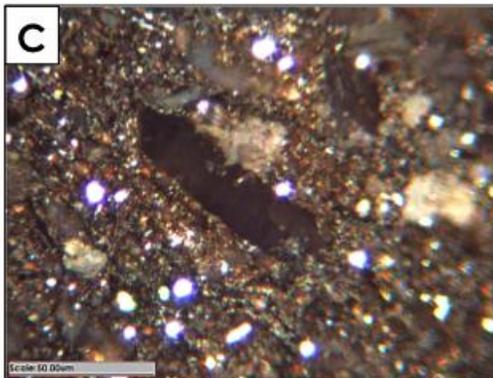
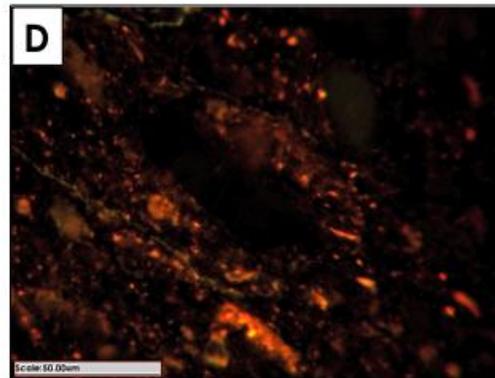
Plate 10 – A and B) White/blue light image pair of grahamite from northeastern Ohio (Ro = 1.19 %), showing characteristic coarse surface texture, C and D) Remnant amorphinite and liptodtrinite in high rank material from northeastern Ohio (Ro = 1.30 %), showing characteristic red fluorescence.
